Wind-Induced Vibration and the Effects on Steel and Aluminum Light Poles

DWM Holdings, January 2016

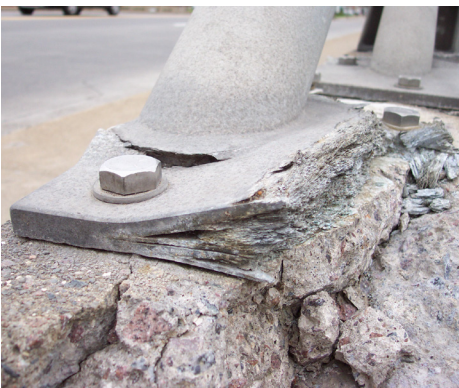
Corrosion at the base of a pole.

To properly conduct a thorough inspection, the inspector should be close enough to touch the pole; a ladder or bucket truck will be required. Start the inspection at the base of the pole and move up to the top. At the base, anchor bolts and leveling nuts should all be accounted for and properly secured. Missing hardware is a sign of improper installation and loose hardware can cause additional movement on the pole, which should always be avoided. The hand hole cover should be removed and the cover and all fittings thoroughly inspected. Along the pole shaft, the area above and below the weld line, the most susceptible area, should be closely inspected for fatigue cracks, dents, and damaged coating. In addition, any rust on steel and corrosion on aluminum should be noted. At the top of the pole, hardware should also be accounted for and properly secured. See examples below.

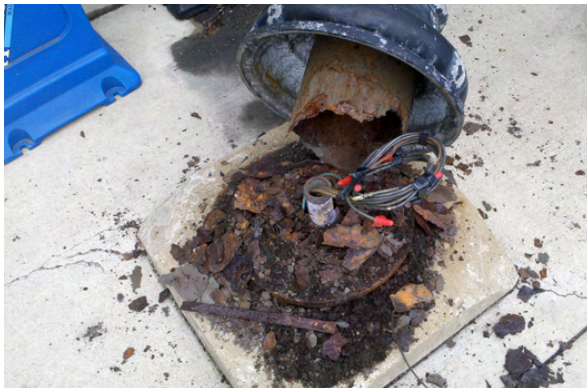
Rust and corrosion inside of a pole.

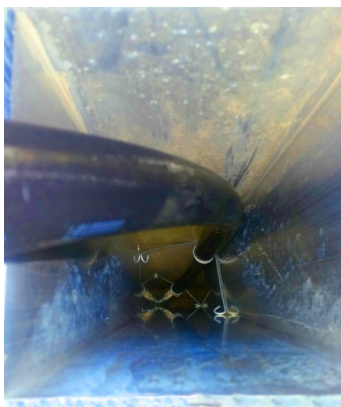
View of vibration dampner inside an aluminum light pole.

Vibration dampeners are offered by pole manufacturers as a vibration mitigation option. DWM Holdings brand companies' vibration dampening system consists of a length of chain encased in a plastic tube that runs approximately two-thirds the length of the pole. This piece disturbs the harmonic cycling of the shaft (Aeolian vibrations) by touching the inside surface of the pole in a random and spiral manner. While the dampener does mitigate the stress effects of the vibration, it is not a guaranteed solve for such an occurrence.
